Shifting Sands: A Journey Towards Coastal Resilience

Using nature-based solutions to restore Fort Erie's Bay Beach

Published by Kiersten McCutcheon on March 1, 2024

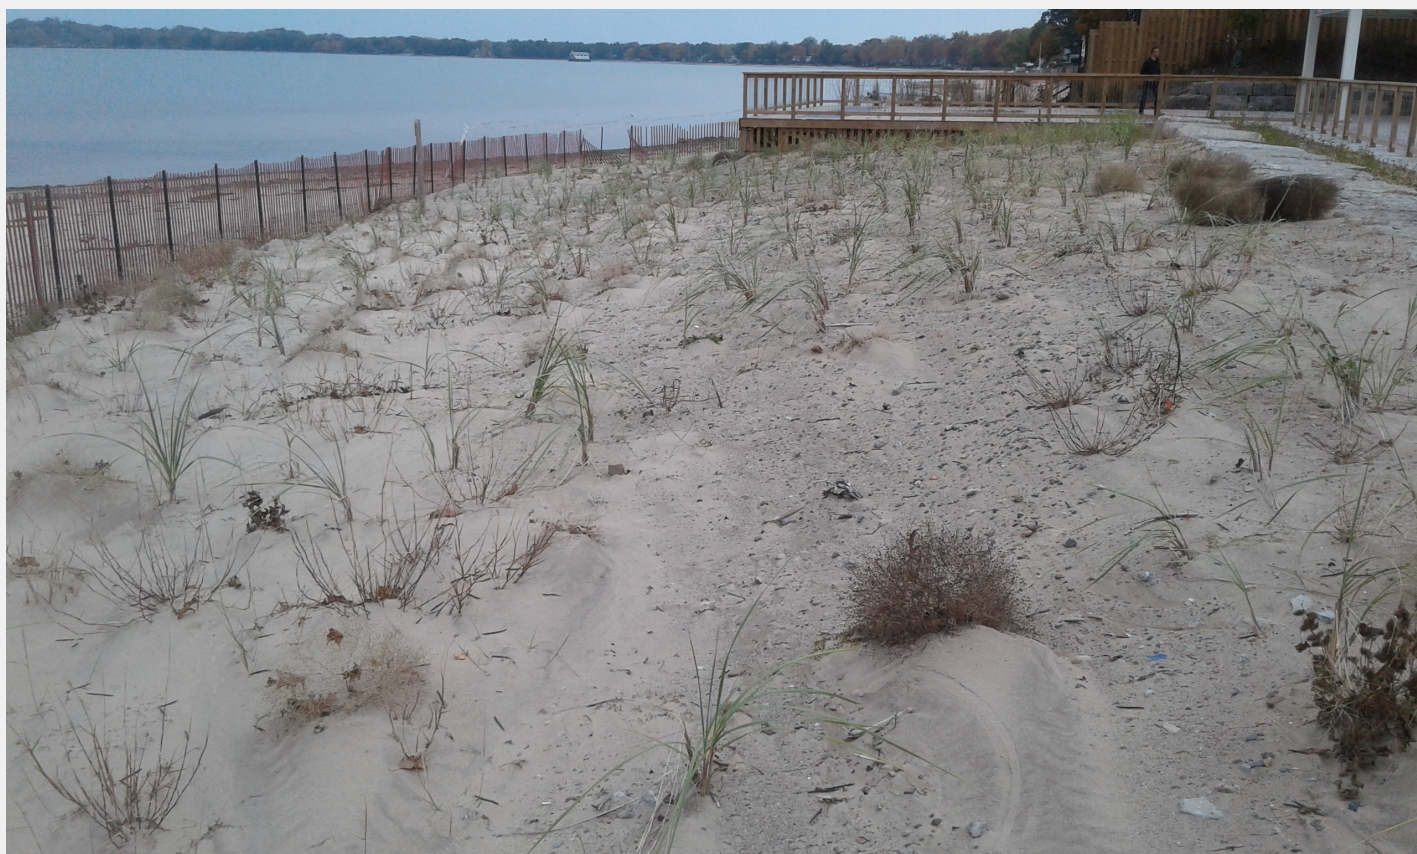
On April 16, 2021, students planted 500 plugs of Great Lakes Champlain beach grass after a storm in 2019 completely destroyed the dune.

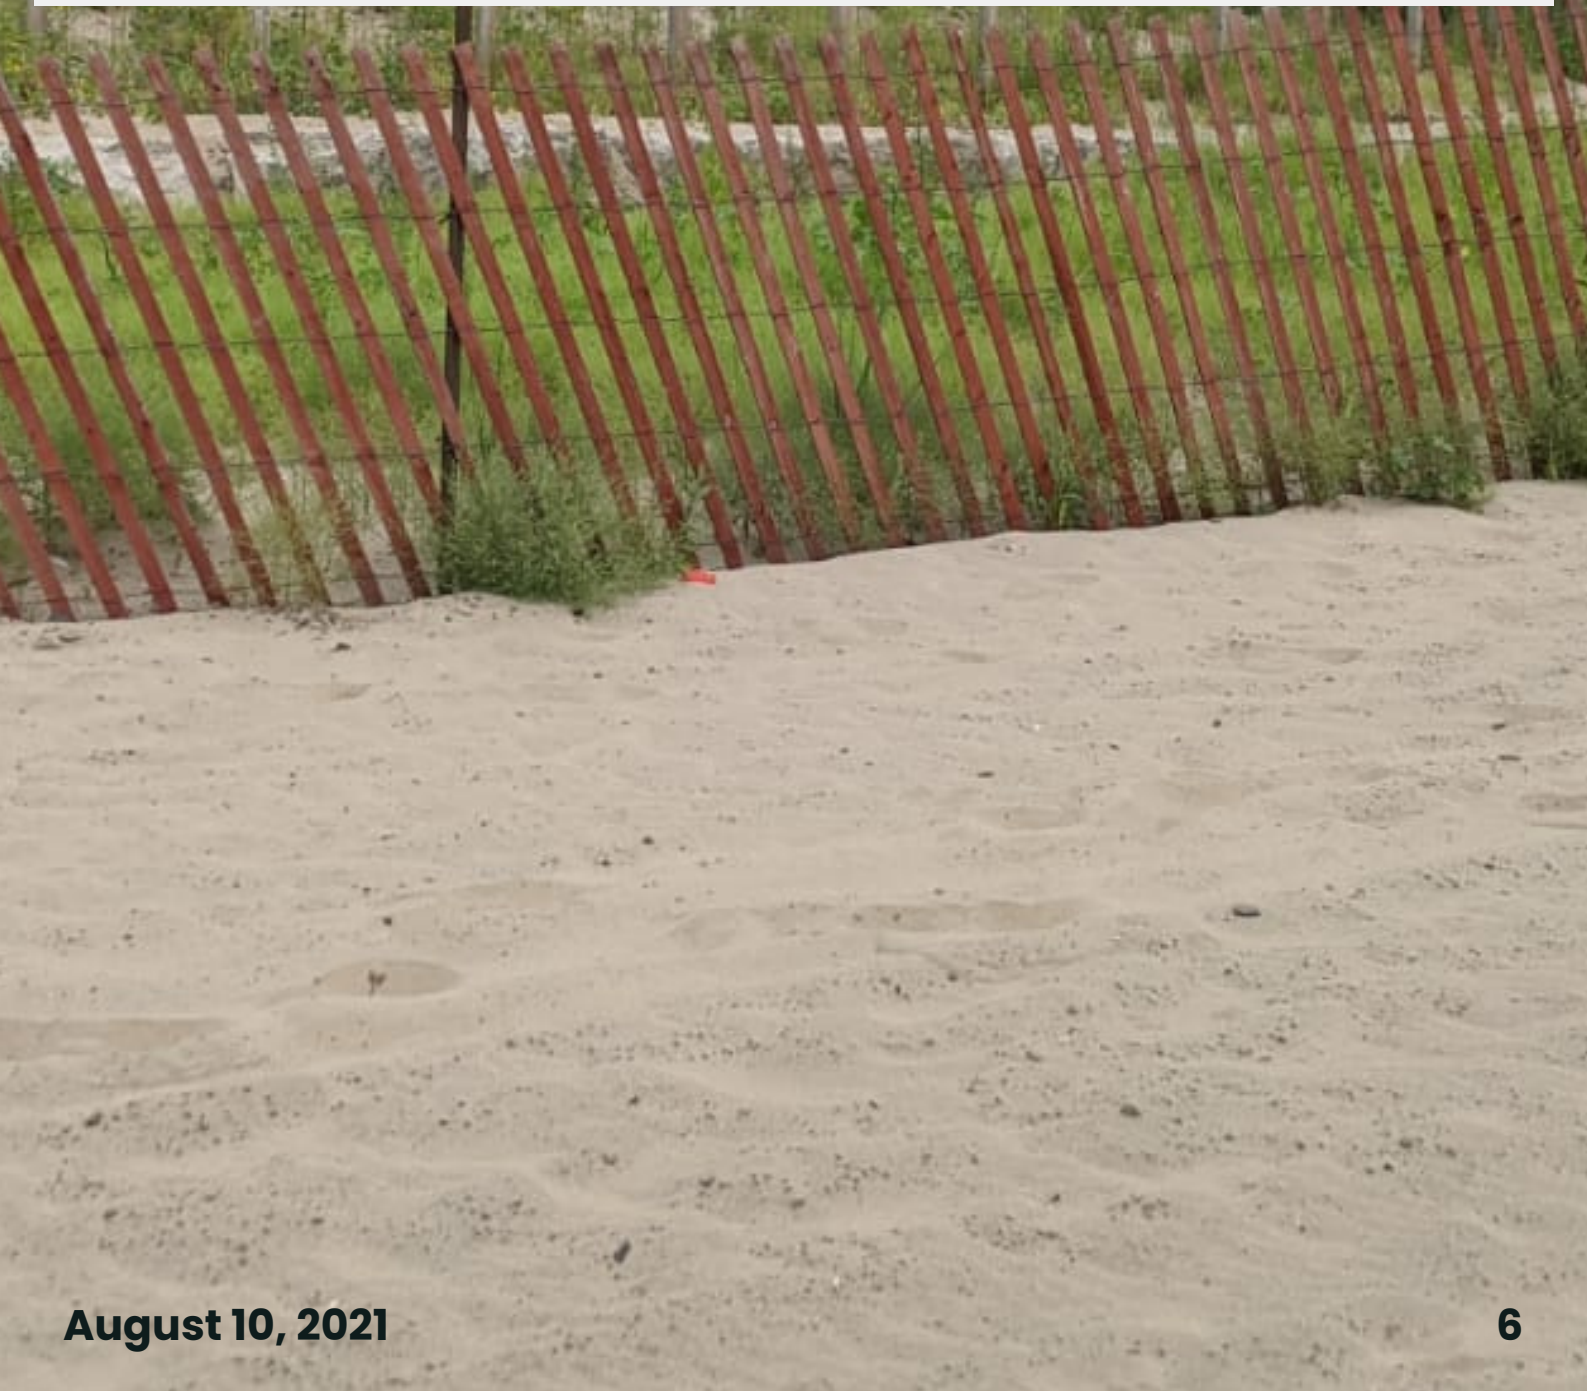
With the area closed off to pedestrian disturbance, other native coastal plants were able to establish. In the image insert below, the planted beach grass can be seen along with a variety of Bugseed; a provincially rare coastal plant.

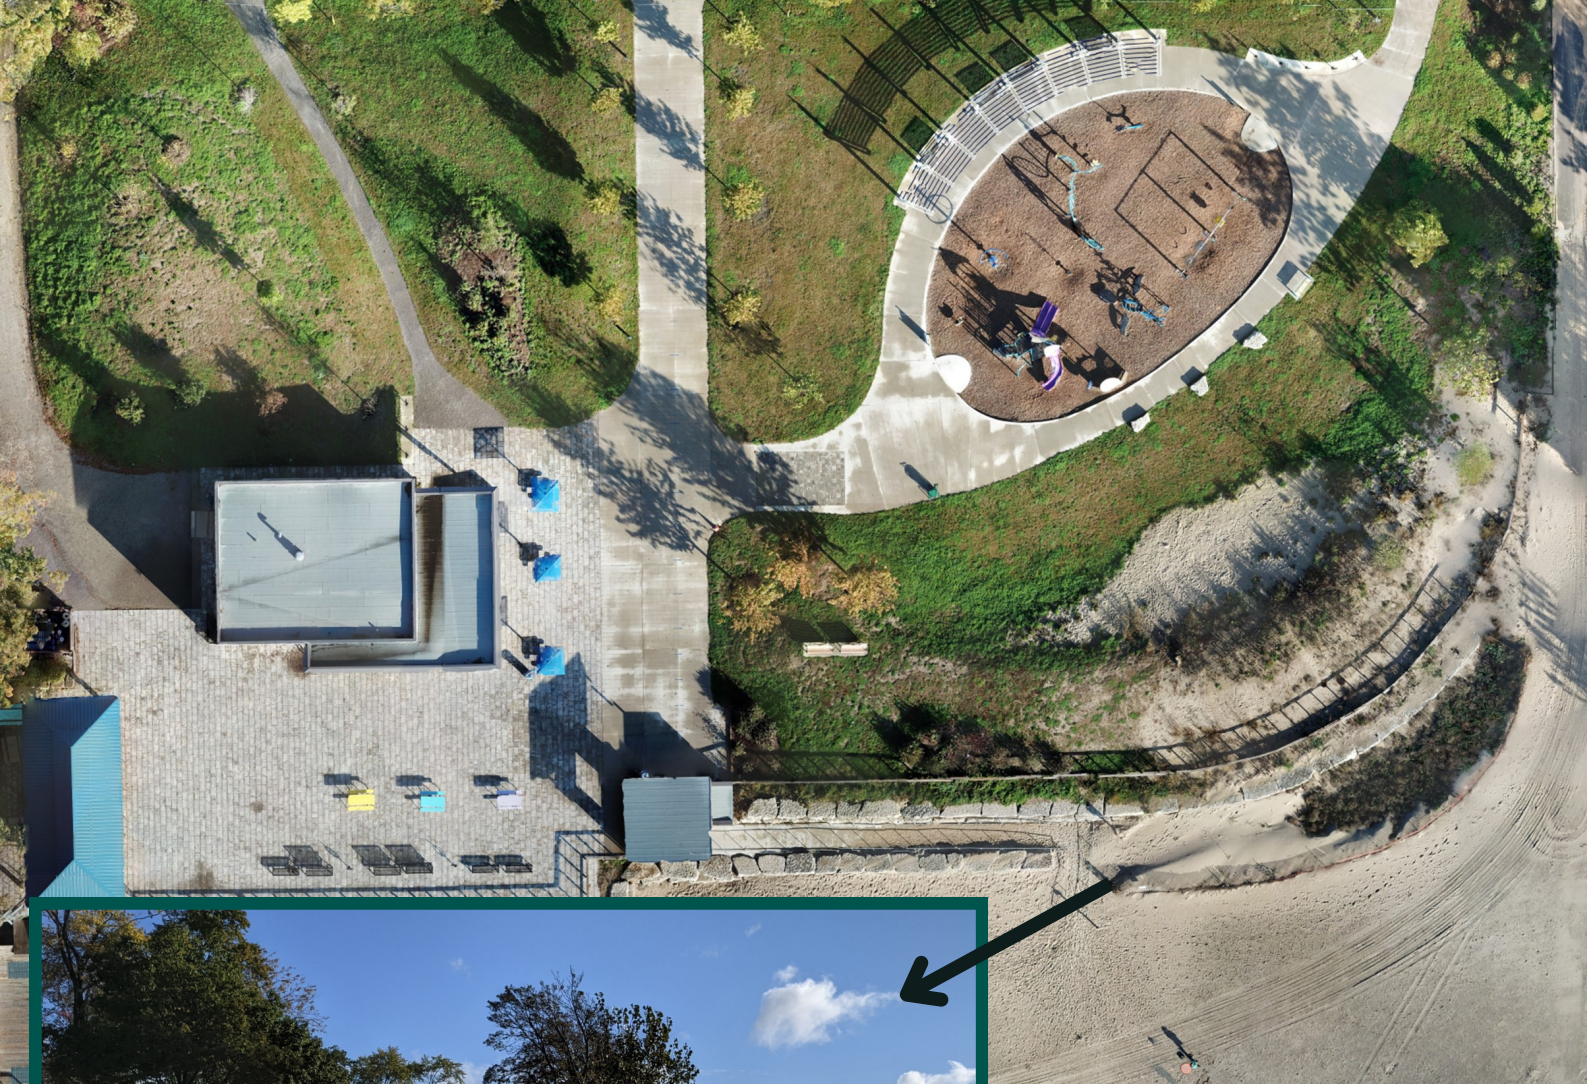
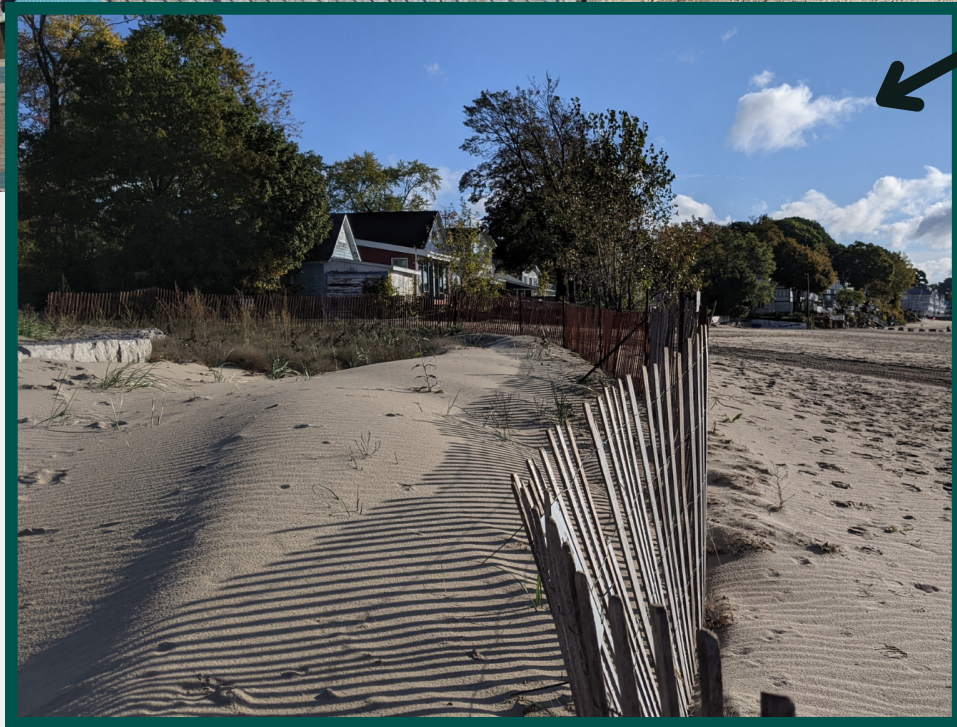
Over the course of the summer and fall, windblown sand was continually deposited within the enclosed area.

A coastal sand dune began to form.

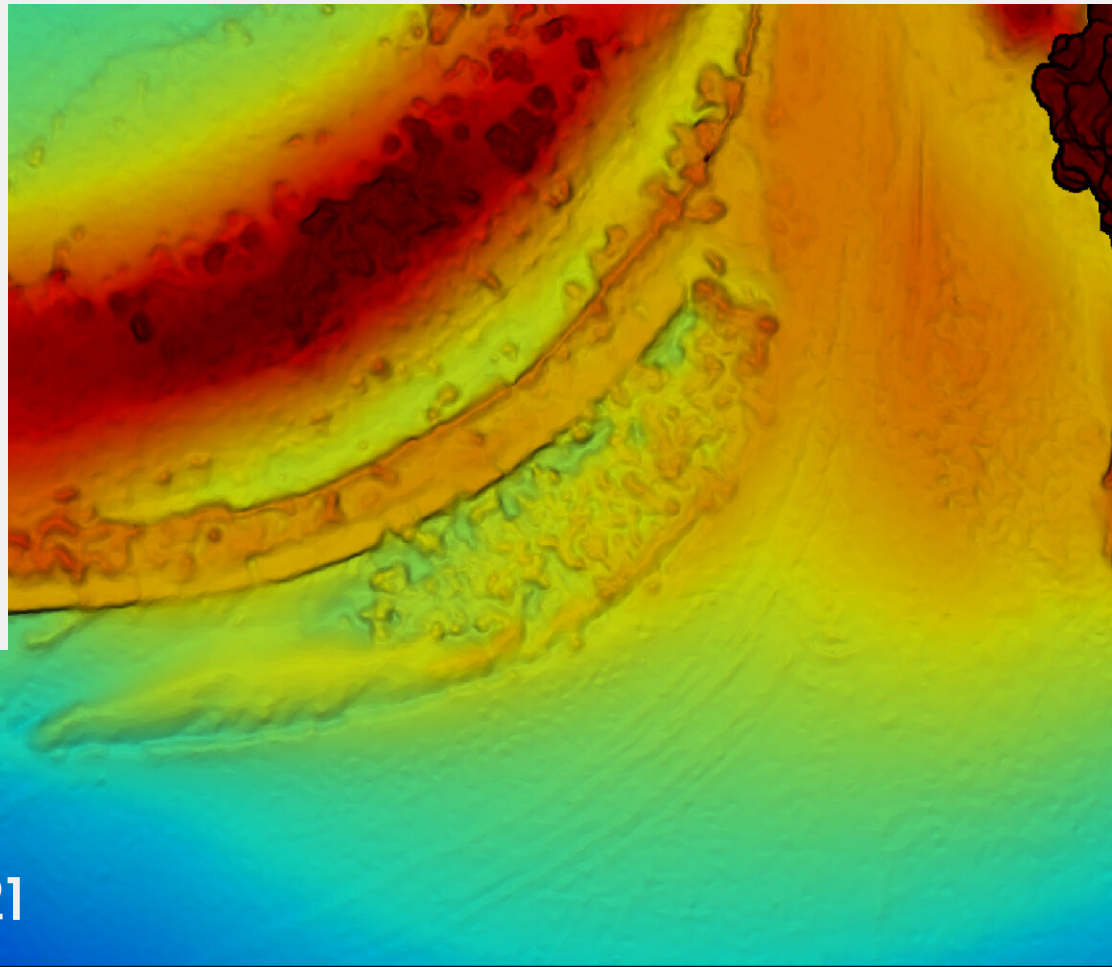
October 27, 2021

Digital Elevation Models for Bay Beach

Note - elevations are relative to each other, not in MASL.

The restored area accumulated a significant amount of sand in 6 months.

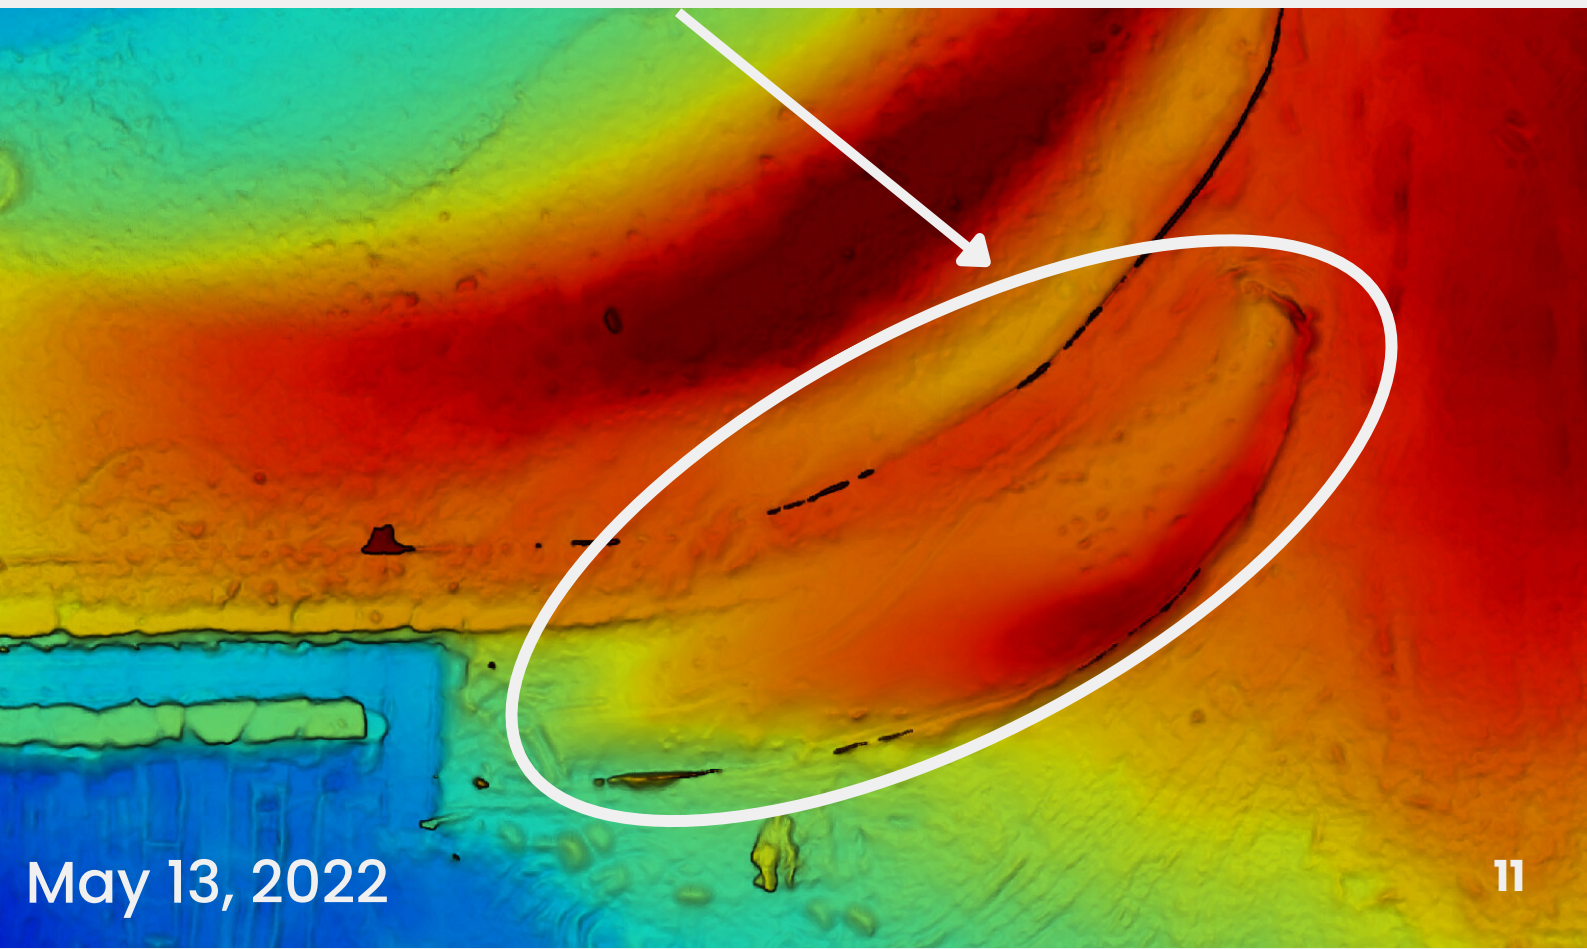
May 13, 2022

By Spring of 2022, the shoots of the planted beach grass began emerging from the sand and have spread to new areas.

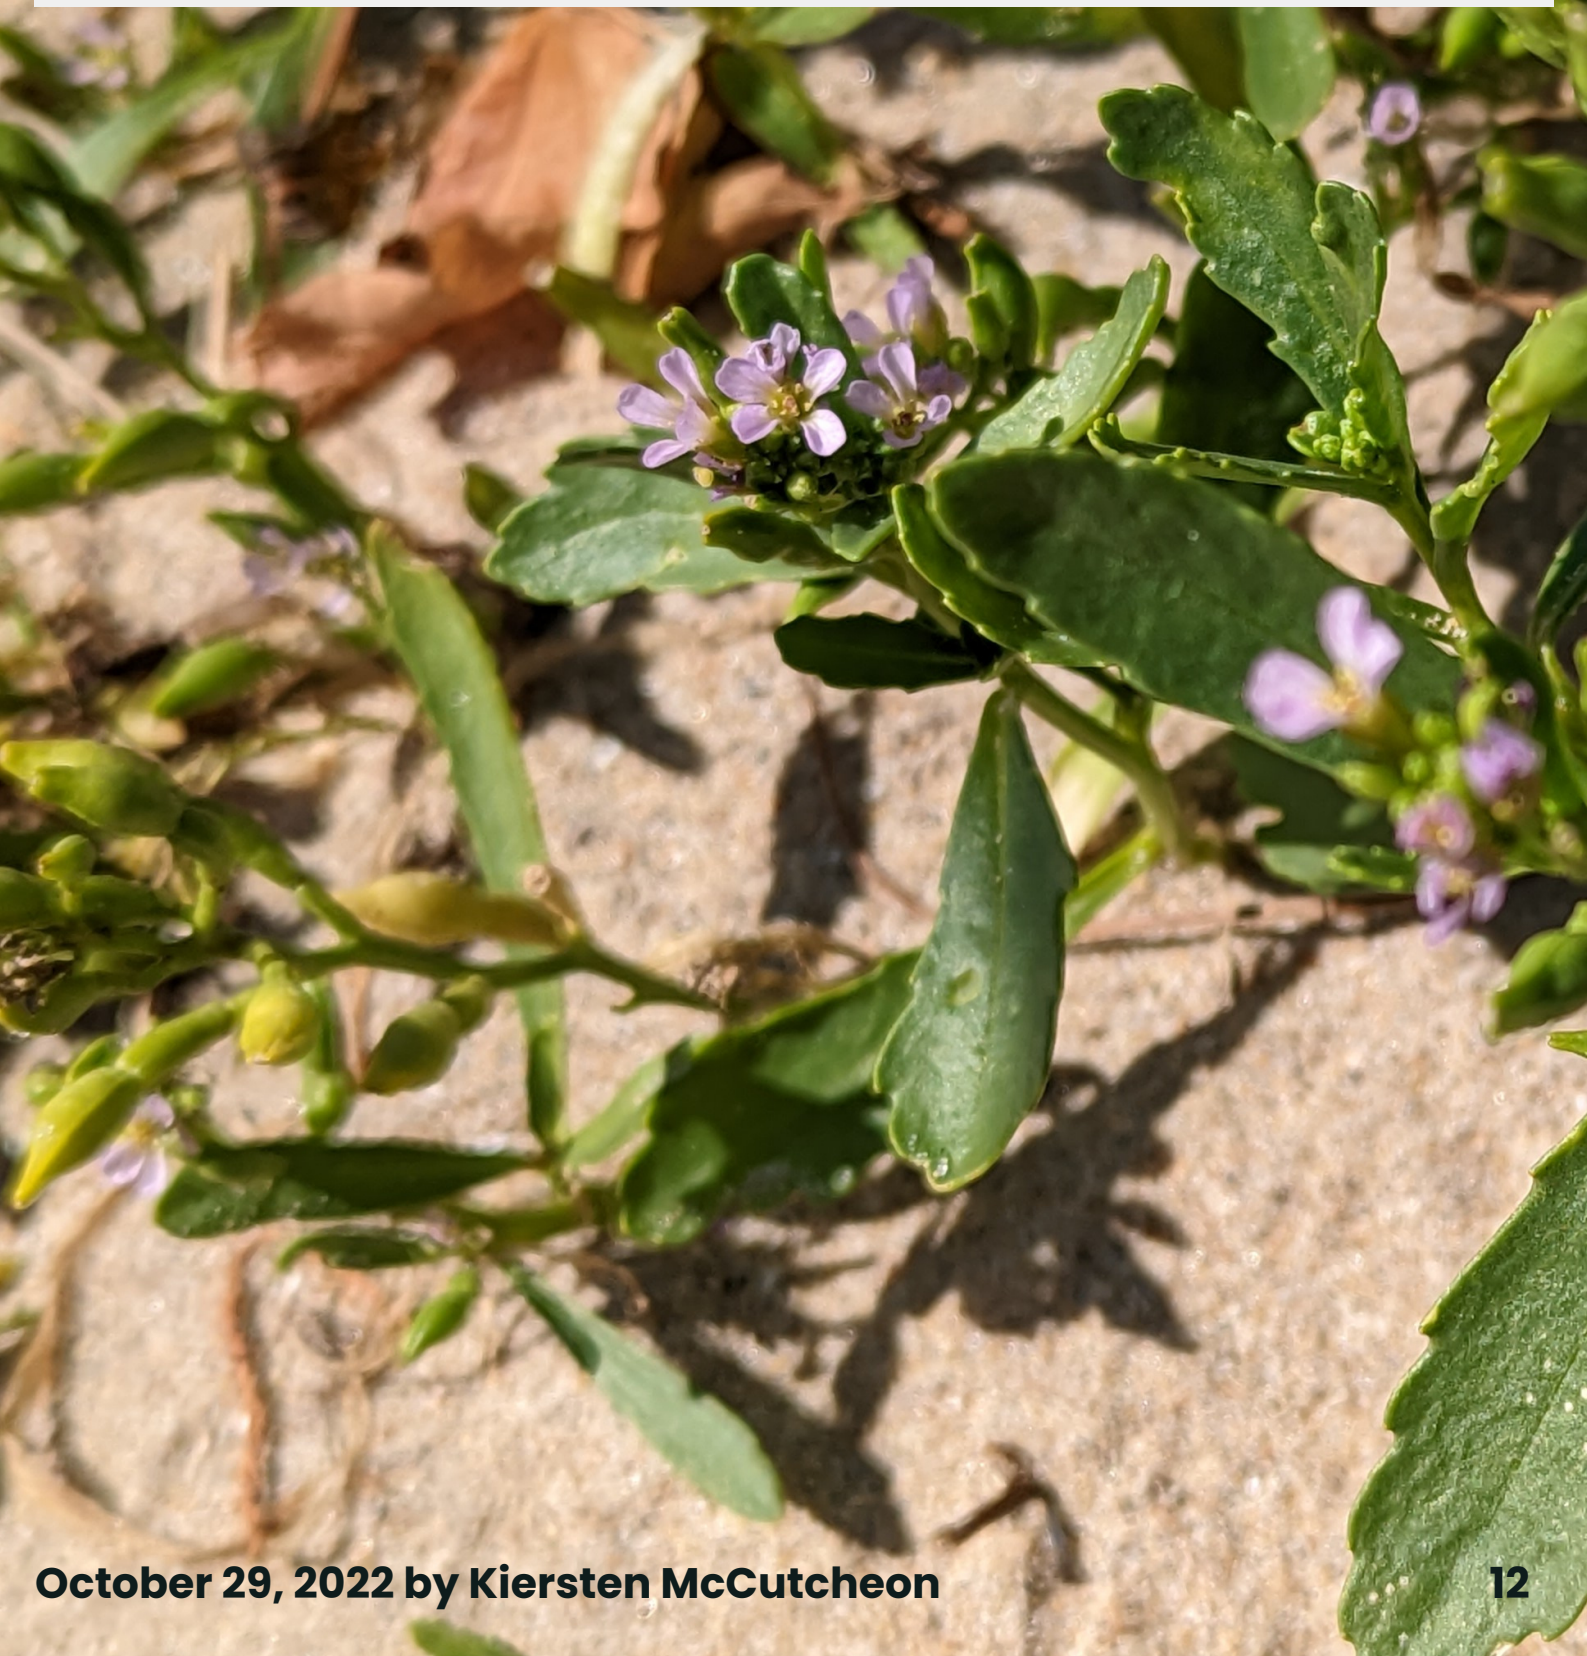
Other native coastal species emerged, like the American Sea Rocket shown below!

With the successful accumulation of sand and established plants, the fencing was no longer necessary to trap windblown sand.

The sand fencing was removed, and a more aesthetic rope and cedar post fence was installed in its place to continue limiting disturbance to the sensitive area by beach visitors.

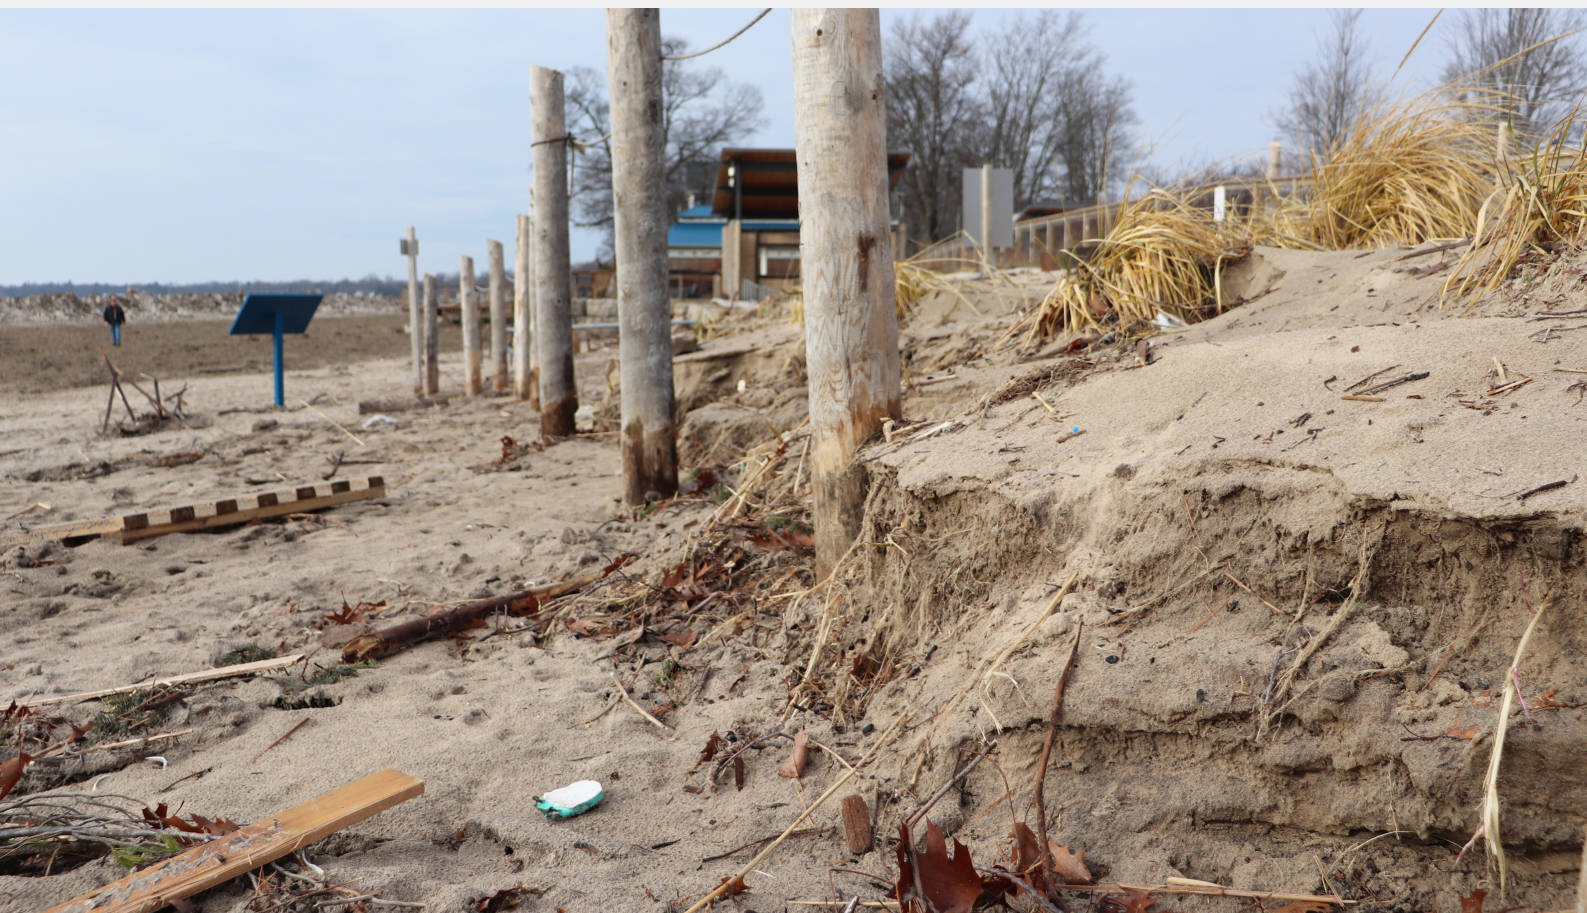
On December 23, 2022, a generational winter storm, dubbed “Winter Storm Elliott,” hit Southern Ontario with brute force. The storm lasted for days and most heavily impacted southern coastal areas of the Niagara Region leaving homes encased in ice.

The sand dune functioned precisely as nature intended, dissipating the storm energy and protecting inland areas from the waves. Neighbouring areas without this protection were not so lucky.
